ASSESSMENT AND STRENGTHENING OF A SIXTEEN STOREY RC BUILDING DAMAGED BY AIR ATTACK

Samir. M. Shihada¹ and M. Al-Jerjawy²

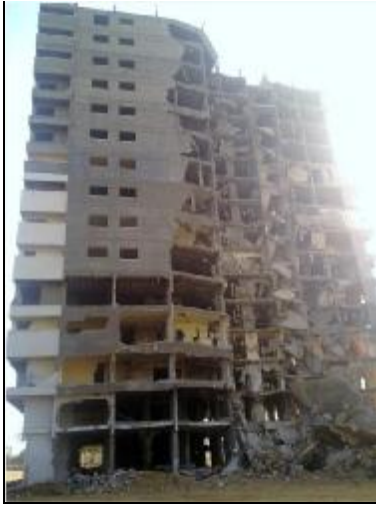
During the aggressive Israeli actions in Gaza Strip within the period between December 27th of 2007 and January 17th of 2008, the tower was exposed to jet fighter missiles causing extensive structural and nonstructural damages to the building. The structural damages included partially and totally-damaged columns, shear walls and slabs along the building height, as shown in Figure (3).

Figure (3-a): Damages in the western side

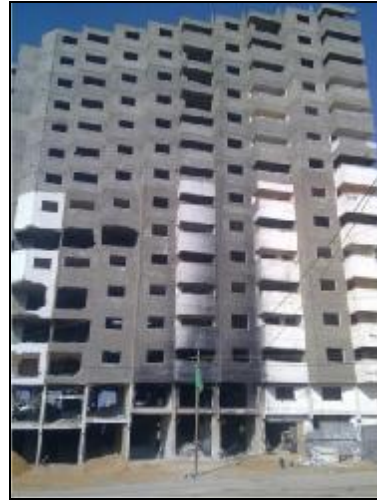
Figure (3-b): Damages in the eastern side

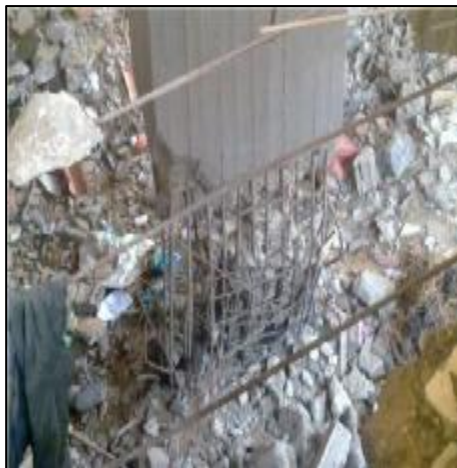
Column C9, C10, C11, C18, C19 and C20 in the basement floor. See Figure (4) for a sample of this category.

Figure (4): Column showing severe damage

These columns were severely damage. Thus, these column, which mainly exist in the basement floor, are to be reconstructed. Column C11 which is used for demonstration purposes is to be reconstructed based on the original design of the building, as shown in Figure (11).

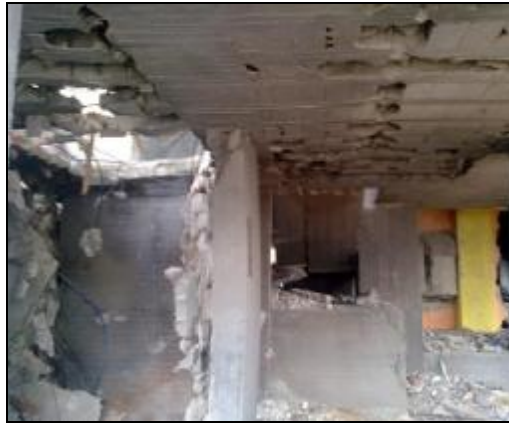
This category includes C13, C23, C24 and C28 in the basement floor. Added to this are columns C10, C13 and C23 in the ground floor. In the mezzanine floor C9, C10, C16 and C18. A sample of this category is shown in Figure (5).

Figure (5): Buckled ground floor column

The columns of this category suffered from cracks and/or excessive deflection. These columns are to be jacketed assuming that the jacket carries the entire axial load. Column C13 is to be considered as a sample of this group.

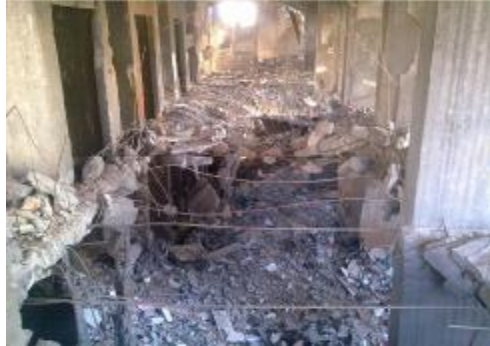
The entire basement slab and all the slabs in the western part of the building (part 2), shown in Figure (6), are completely destroyed.

Figure (6): Part of the destroyed basement slab

The basement slab is divided into two parts and a construction joint is proposed between the two parts, where columns CN1 through CN9 are to be added and anchored to the mat. Part (2) is to be designed as hollow-block ribbed slab, 30 cm in thickness. The main beams are to be designed as simply supported beams due to the presence of columns and shear walls (see Figure 13-a).

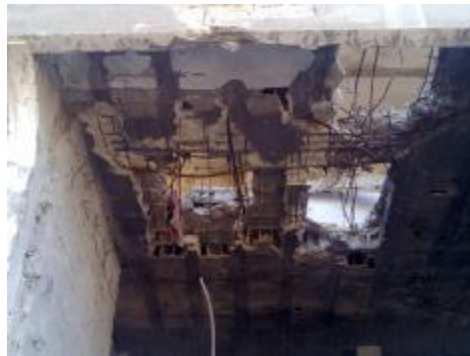
Limited parts of the ground floor slab of the building are severely damaged, as shown in Figure (7).

Figure (7): Limited damages in ground floor slab

Damaged panels in the ground floor slab is to be reconstructed as shown in Figure (14).

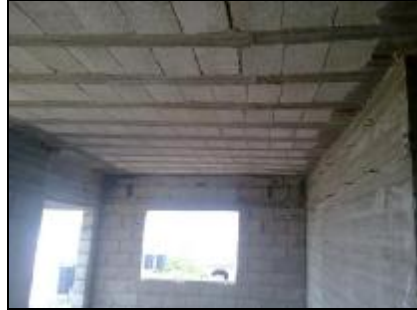
A small panel in mezzanine floor slab and another in first floor show excessive deflection and structural cracking. The excessive deflection and cracking are attributed to the damage caused to column C11 in the basement floor (see Figure 8). Also, one panel in the fourth floor slab is partially damaged. Moreover, one panel of the fourth floor slab of part (1) of the building shows limited damages.

Figure (8): Excessive deflection of a panel in second floor slab around column C11

- The severe damage incurred to column C11 is accounted for in the ETABS-9 model by including a 20-cm support settlement. This caused high moments in parts of the mezzanine and ground floor slab beams, around column C11, with decreasing effect towards the top of the building. The increase in bending moments for two affected beams is shown in Table (2).

Parts of the slab around column C11 are to be reconstructed in ground floor and mezzanine floor slabs, as shown in Figure (15-a). Reconstructed panel of the fourth floor slab is shown in Figure (15-b).

3. For the slab surrounded by (W5, W6 and C6), ETABS-9 analysis showed additional moment in some supporting beams, as well as in slabs caused by shortening of column C11. Visual inspection showed that this slab is deflected in the mezzanine and ground floor slabs. So, this panel should be removed and re-casted, based on its same design of slab reinforcements and shear connectors.
4. For all new concrete used for rehabilitation, expanding agents must be added to the mix to ensure gap fillings. Old surfaces must be cleaned, roughened and painted by epoxy agent to enhance bonding between old and fresh concrete. Shear connectors must be covered by bonding agents (concrete-steel) to guarantee fixation in old concrete, then driven into it.

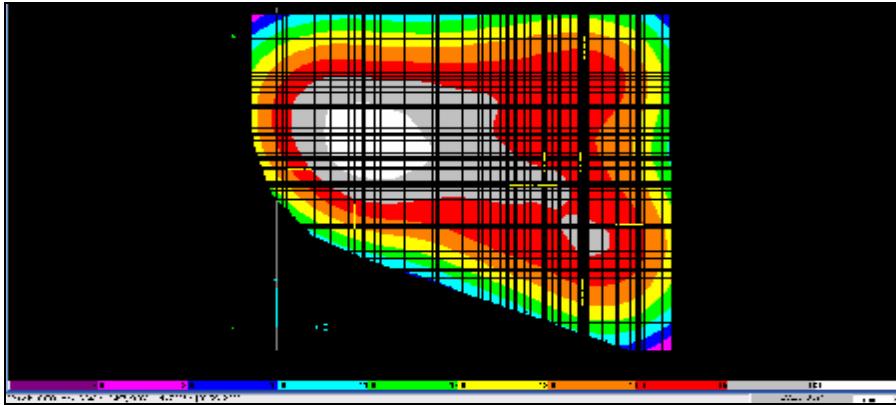
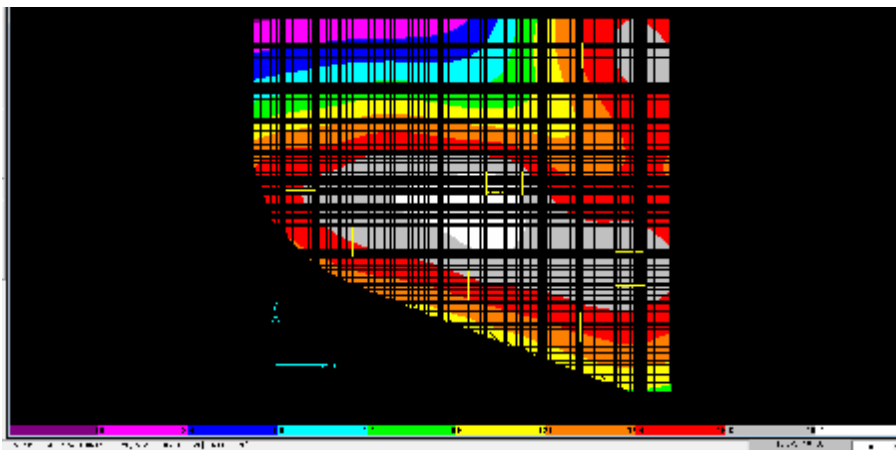
- Slab design, column design and shear wall design are satisfactory.
- The soil pressure under the mat increased from 16.65 t/m^2 before the sustained damages to 20.85 t/m^2 after the damages. This is still within the allowable bearing capacity of the soil as stated in the geotechnical investigation of the building site (see Figure 10 for SAFE-8 results).

Figure (10-a): SAFE-8 results show that maximum soil reaction is 16.65 t/m^2 (before)

(10-b): SAFE-8 results show that maximum soil reaction is 20.85 t/m^2 (after)
