## STRUCTURAL PERFORMANCE OF REPAIRED CORRODED REINFORCED CONCRETE BEAMS

Mohammed AL-Ibweini<sup>1</sup> and Mohammed Ziara<sup>2</sup>

**Abstract:** The undertaken research work included in the paper presents the results of a laboratory investigation of the structural behavior of corroded and repaired beams in comparison with undamaged identical beams. The investigated structural behavior included shear and flexural strengths, ductility expressed by the middle span deflection, crack development and mechanical properties of the corroded reinforcing steel bars. The test program included fourteen beams; ten out of them were tested as simply supported beams subjected to two concentrated point loads. Two out of these ten beams acted as control beams, other two as corroded beams without repair and the remaining six beams were repaired after been corroded using different repair techniques. The other four were used to investigate the corrosion rate and the mechanical properties of the corroded steel bars. Special laboratory setup was assembled to allow fast corrosion of beam reinforcement. An electrochemical system was used to achieve the specified corrosion level. Repairing of beams wa

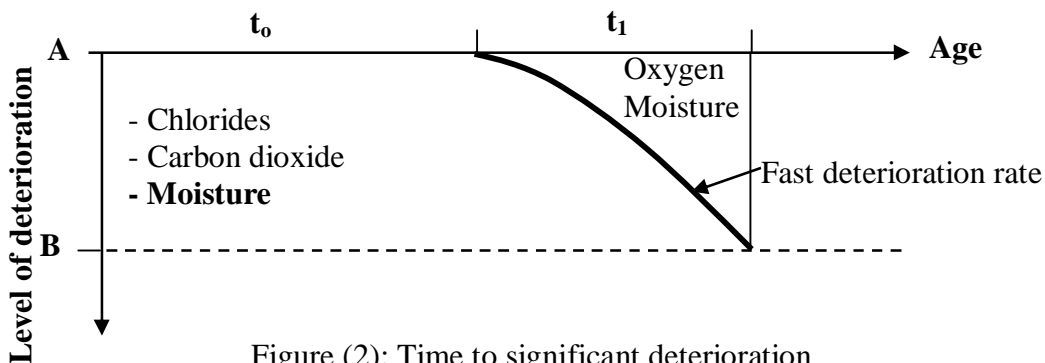
Figure (2): Time to significant deterioration

and mathematical models have been proposed to estimate the time of corrosion initiation and propagation. Tutti's two-stage model shown in Fig. 2 was proposed to predict the service life of reinforced concrete structures [7]. Stage 1 is reached when the chloride or carbonation has reached the reinforcement. Stage 2 is reached when corrosion due to oxidation of the

steel has been developed sufficiently for spalling and cracking of the cover to occur. The concept of this model is to divide the service time of the structure into  $t_0$ , as the time to corrosion initiation, and  $t_1$ , as the time taken for deterioration of a sufficient level to occur to be of concern.

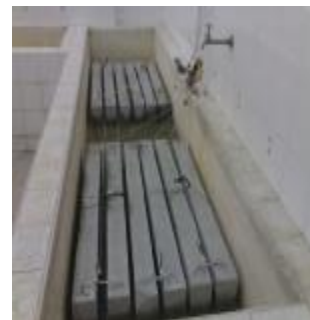
Figure (6): Test beam

Fig. 6 shows a photo of the test beams inside the basin during the corrosion process. The negative power supply was connected to external steel rods immersed in the aqueous solution to act as cathode. The resulted electric circuit forced steel ions to translate from anode to cathode. A basin was filled in the laboratory with a sodium chloride solution (5 percent NaCl by weight of water) to act as the aqueous solution. The solution covered 30mm of the beam height in which the flexural reinforcements was placed. This was to ensure that enough oxygen needed for the corrosion mechanism exists in the vacancy of the reinforcement. The electric wires were attached to the reinforcement bars. The beams were connected in parallel to +5 Volts with a capacity of 25 Amperes electric DC current generated by power supply, which impressed an equal voltage on each beam. The negative power supply terminal was connected to twelve 10 mm steel rods immersed in the aqueous solution between the beams in order to facilitate the opening and closing of the electric circuit. The required corrosion level was achieved (crakes appear along longitudinal reinforcements) in about three months.

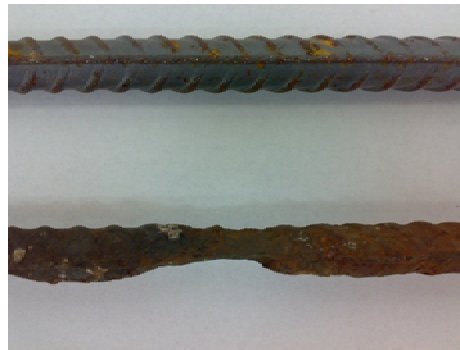
**Figure (7): Corroded and Non-corroded steel reinforcement bars**

The requirements of the serviceability limit state can be evaluated based on the ductility and cracking obtained from the test beams. The elongation tests carried out on the corroded steel bars have shown a significant reduction in the measured deformation up to 83% compared to non corroded steel bars. Despite of this, the repaired beams have achieved comparable deflection level as the controlled beams as shown in Fig. 8. The enhanced ductility of the repaired beams is attributed to the additional supplementary steel bars.

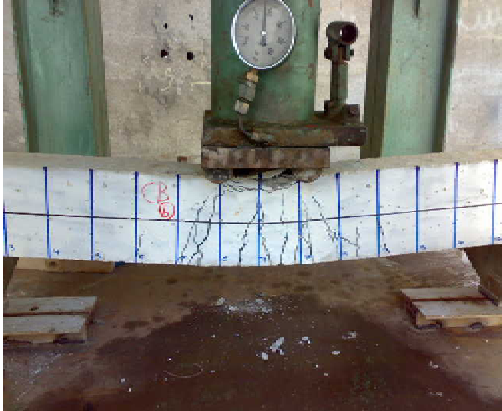
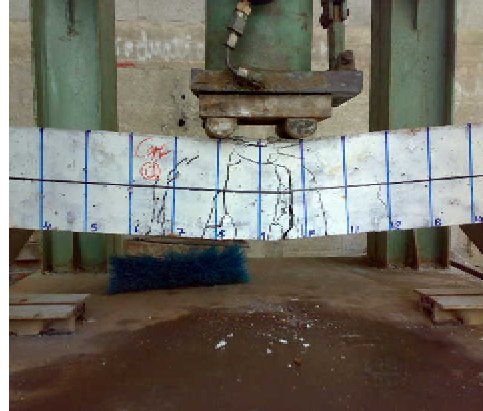
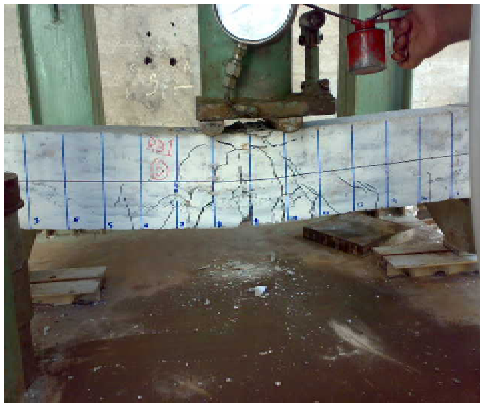
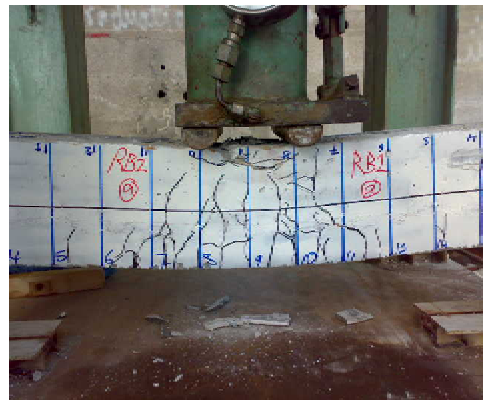
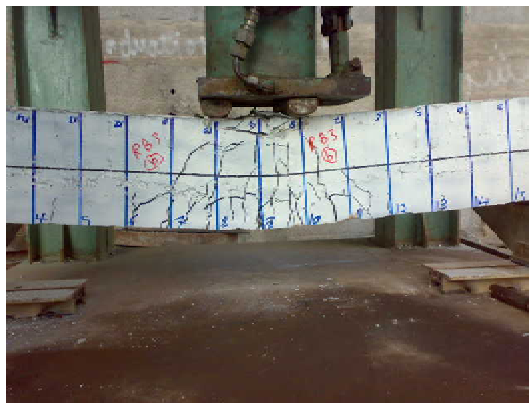
Figure (9): Crack patterns

Fig. 9 includes photos of typical cracked patterns obtained from controlled, corroded and repaired beams. Regardless of the repair type used, the repaired beams have shown cracking widths and patterns similar to that obtained from the controlled beams. The corroded beams exhibited excessive crack widths, especially at the flexural reinforcement level.

Control beam C B1

Corroded beam Co B1

Repaired beam R1 B2

Repaired beam R2 B1

Repaired beam R3 B2
