ASSESSMENT AND STRENGTHENING OF A SIXTEEN STOREY RC BUILDING DAMAGED BY AIR ATTACK

Samir. M. Shihada¹ and M. Al-Jerjawy²

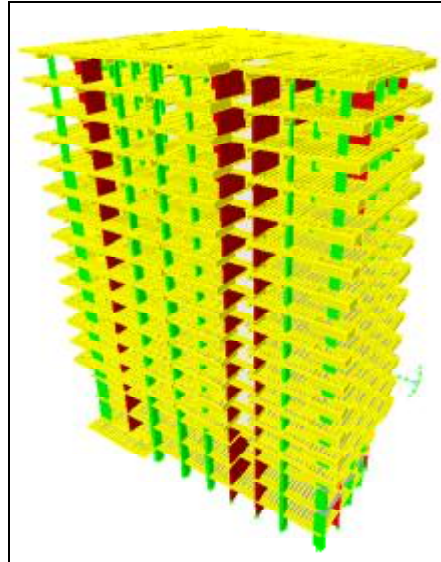
Figure (9): The 3-D ETABS-9 building model

The building before sustaining the damages was originally designed according to ACI 318-95 as the structural code and UBC-97 as the building code. Then, a three-dimensional model of the structure was created using ETABS-9 to carry out the static analysis. In addition, analysis of the mat foundation was carried out using SAFE-8.

The ETABS-9 model included defining a new model, defining materials and sections, adding the geometry, meshing, defining loads and load cases, assigning the supports, checking the model, running the analysis and obtaining the results. At the end of this work the model looks liked the one shown in Figure (9).

Based on the results obtained from ETABS-9 and SAFE-8 models, the structural design of the building was checked based on ACI 318-95 and UBC-97. Design checks included slab design, column design, shear wall design and mat foundation design. Moreover, soil pressures under the mat before and after the incurred damages were evaluated. These design checks showed the following:

- Slab design, column design and shear wall design are satisfactory.
- The soil pressure under the mat increased from 16.65 t/m^2 before the sustained damages to 20.85 t/m^2 after the damages. This is still within the allowable bearing capacity of the soil as stated in the geotechnical investigation of the building site (see Figure 10 for SAFE-8 results).
